WHITE PAPER

Sensor Alignment for Alvium Cameras

V1.2.0
2025-Jul-22

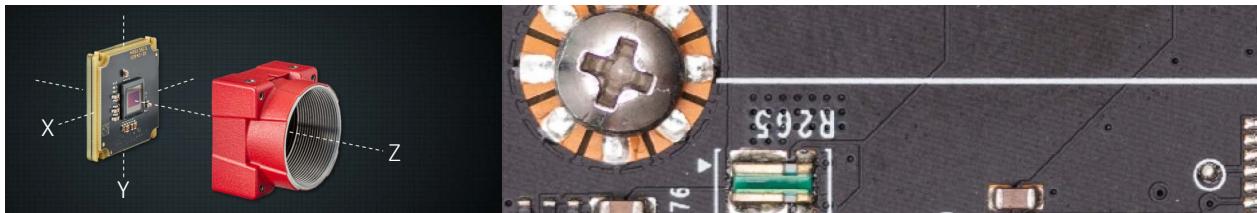
The image shows no alignment issues.

Figure 4: The sensor is accurately aligned to the optical axis of the lens

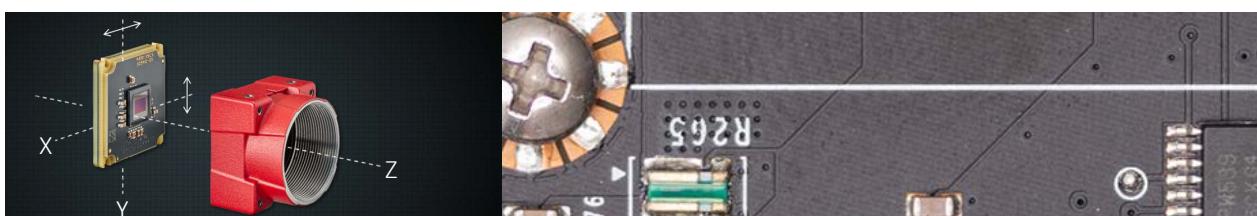
The image is shifted to the right by 200 μm (~66 pixels). The screw head is cropped on the left.

Note: Depending on the lens, the sharpness can be different between the image corners. Potential vignetting is shifted out of center as well, which is harder to correct than typical vignetting that is centered.

Figure 7: The sensor is shifted along the X-Axis
